# **Code of Practice**

## **Upstream Polyethylene Gathering Networks - CSG Industry**

### **Companion Paper CP-03-002 Guidelines for Acceptance Criteria of Surface Discontinuities**

**June 2025**

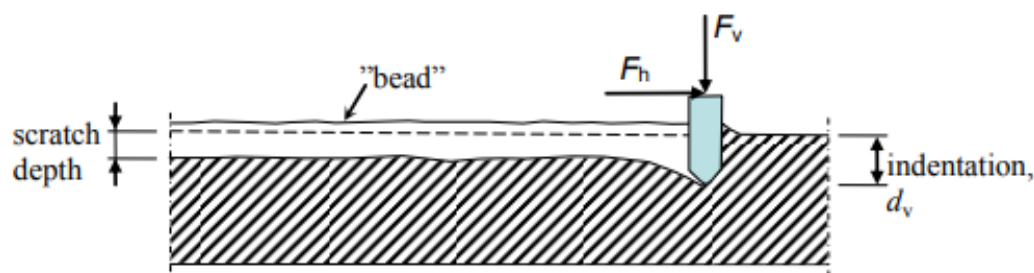
**Figure 1** — Morphology of a scratch or gouge in HDPE pipe

To facilitate the decision whether a discontinuity is a scratch or a gouge, consider Figure 1. If the height of the bead is minor or non-existent, the discontinuity can be regarded as a scratch. If the bead indicates significant deformation, then the defect can be regarded as a gouge. The width of a gouge will also be wider than a scratch, (for example see Figure 5.2).

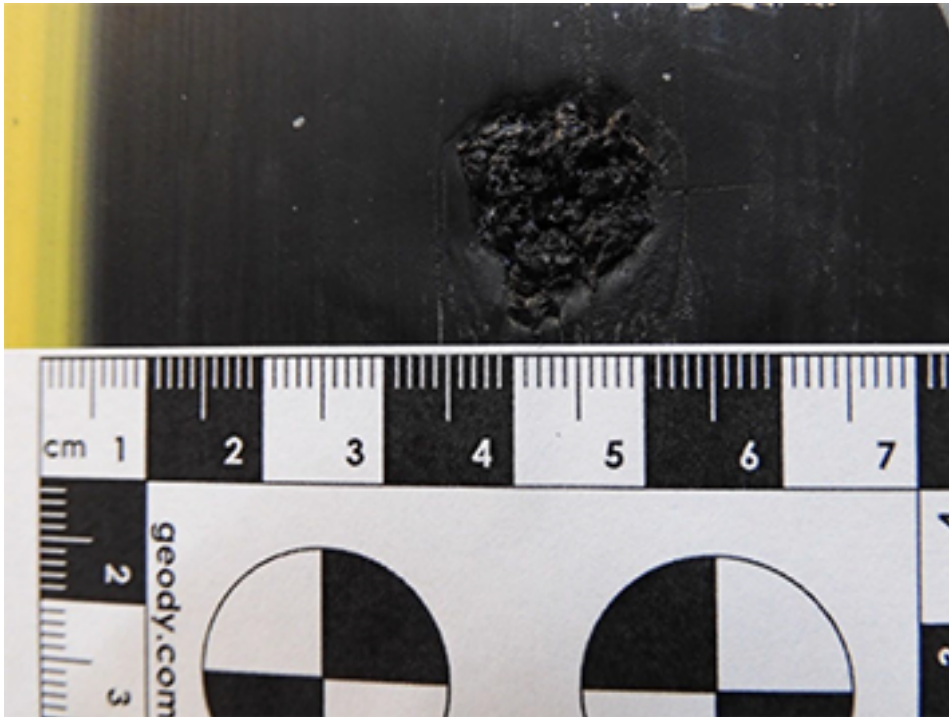
**Figure 4-1** — showing a scab consisting of fine folds or flakes of extruded HDPE resulting in a roughened surface

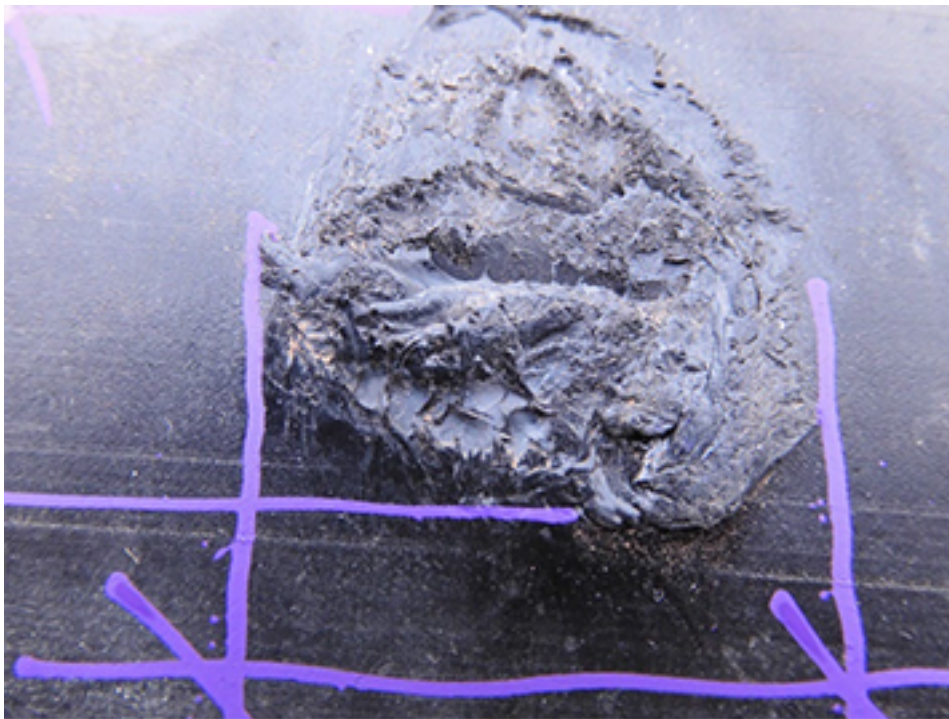
**Figure 4-2** — showing a scab consisting of fine folds or flakes of extruded HDPE resulting in a roughened surface

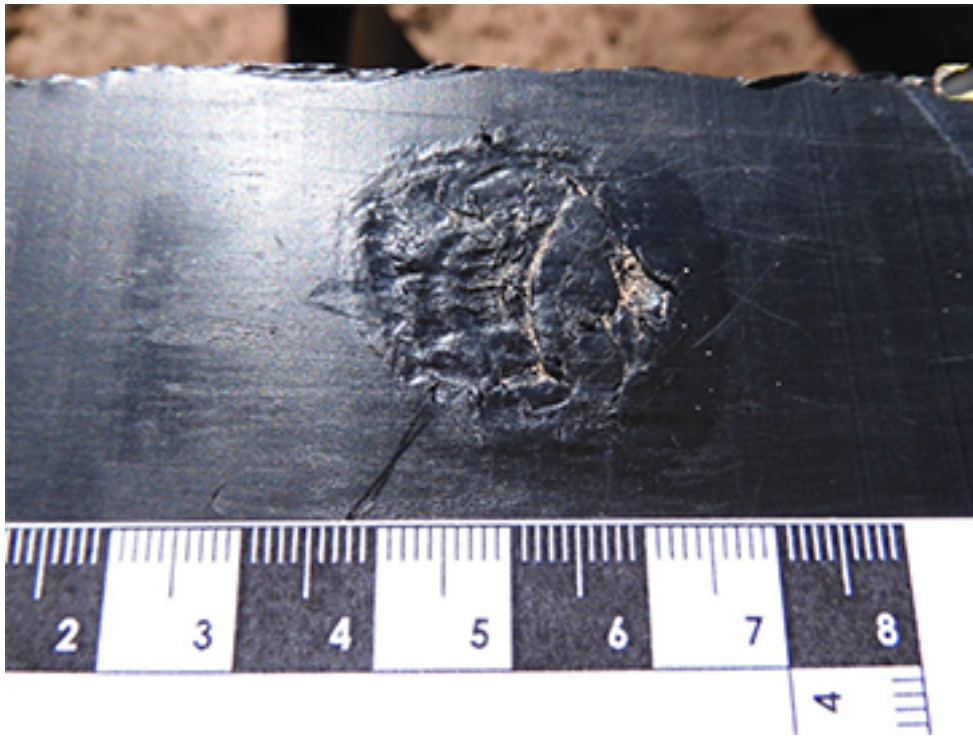
**Figure 4-3** — Scab — notice scabs have little depth around the edge

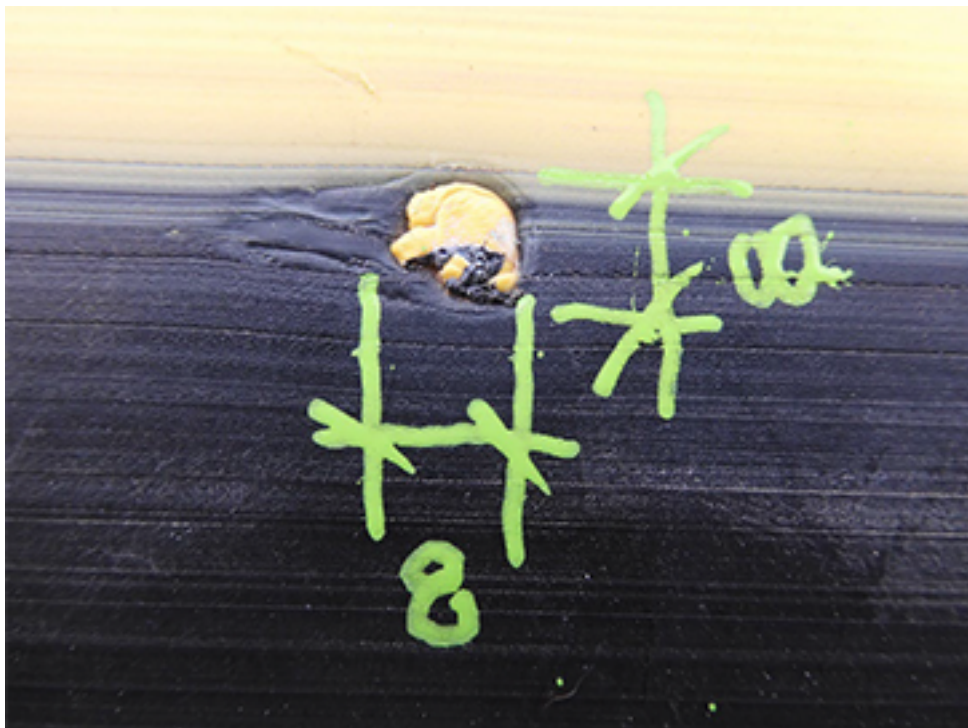
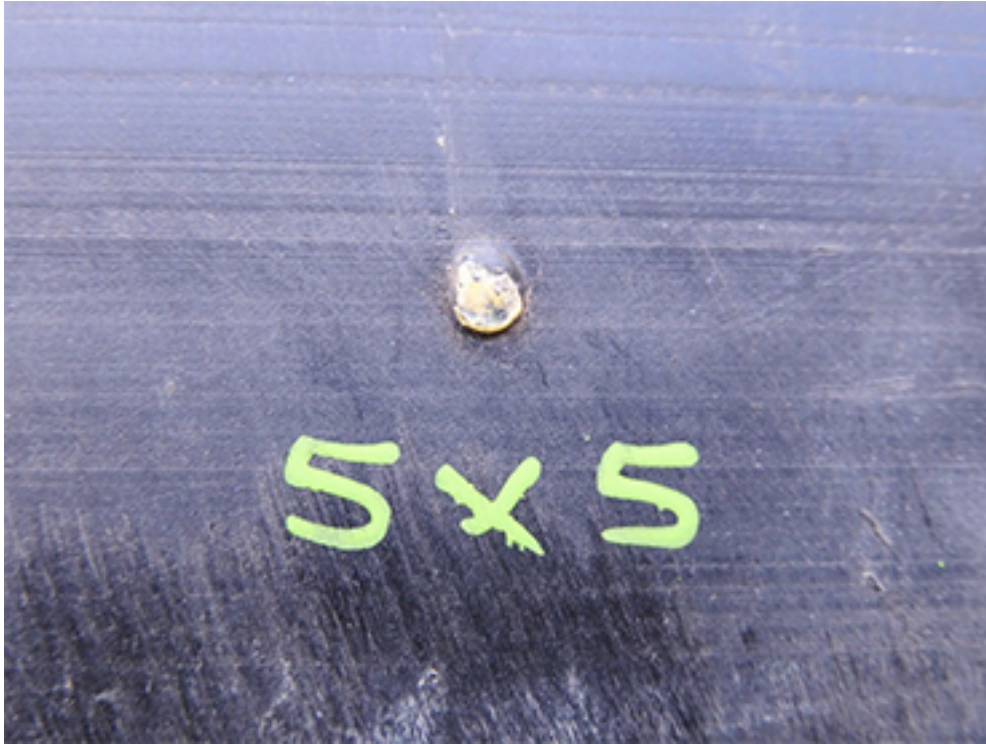
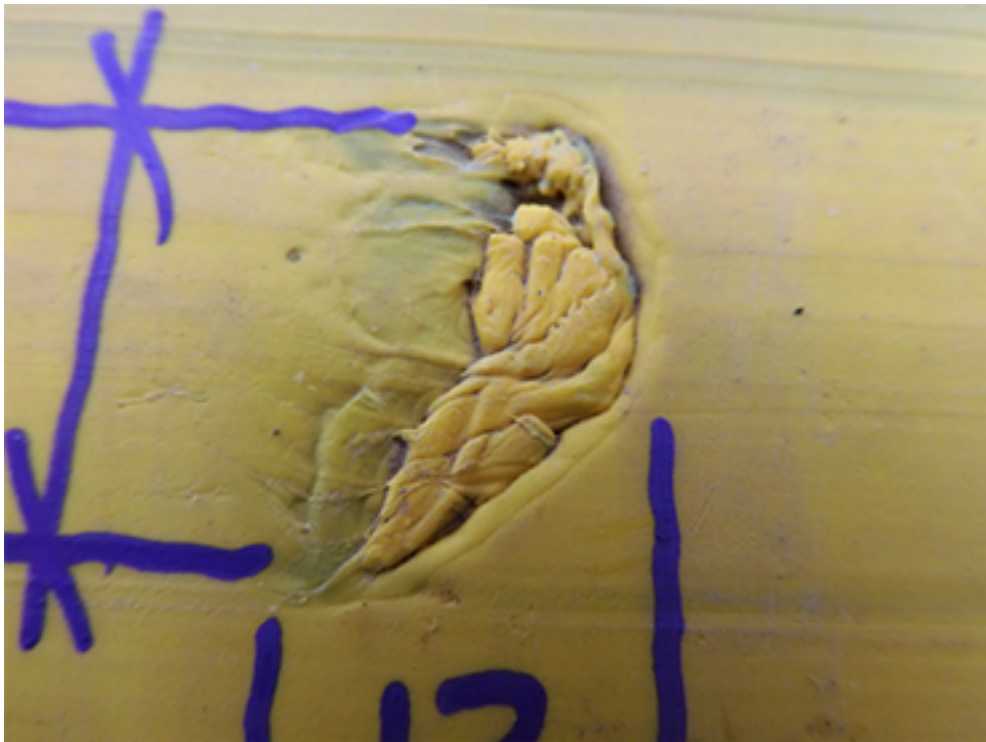
Distinguishing characteristics	Acceptable depth	Acceptable length or area	Examples
Pipe manufacture	Blisters	Flakes with a shallow appearance almost flush with the surface of the pipe with little depth around the edges.  <b>Note:</b> Where doubt exists regarding this classification, the defect shall be evaluated using the SURFACE INCLUSIONS acceptance criteria	Not acceptable		
	Voids				
	Burnt particles				
	Heat marks				
	Delamination				
	Scabs (isolated surface roughness)		10% of wall thickness, max	35mm x 35mm max.	Figures 4-1, 4-2 and 4-3
	Resin inclusions	The resin inclusion have the shape of a one or more resin pellets pressed into and bonded with the pipe material. Easy to distinguish since the resin inclusions are only seen for the resin	10% of wall thickness, max	20mm x 20mm max.	Figures 4-4, 4-5, 4-6

**Figure 4-4** — Resin inclusion

**Figure 4-5** — Resin inclusion

**Figure 4-6** — Resin inclusion

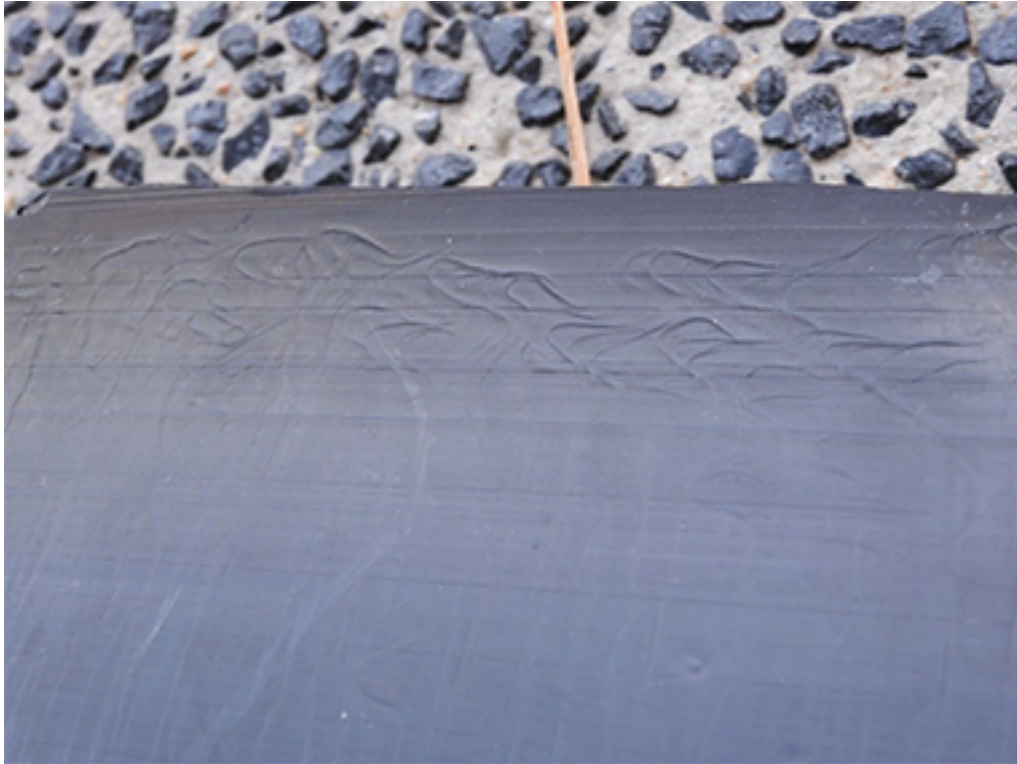
**Figure 4-7** — Shallow surface ripples, "watermarks" typically covering a large percentage of the pipe surface

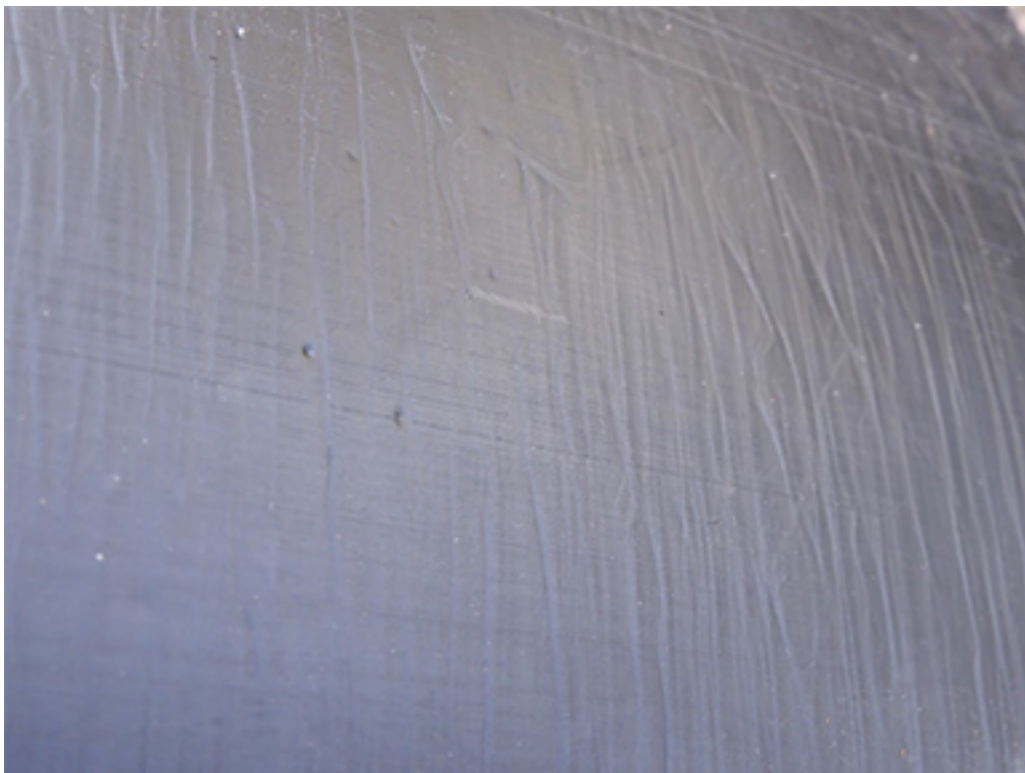
**Figure 4-8** — Watermarks

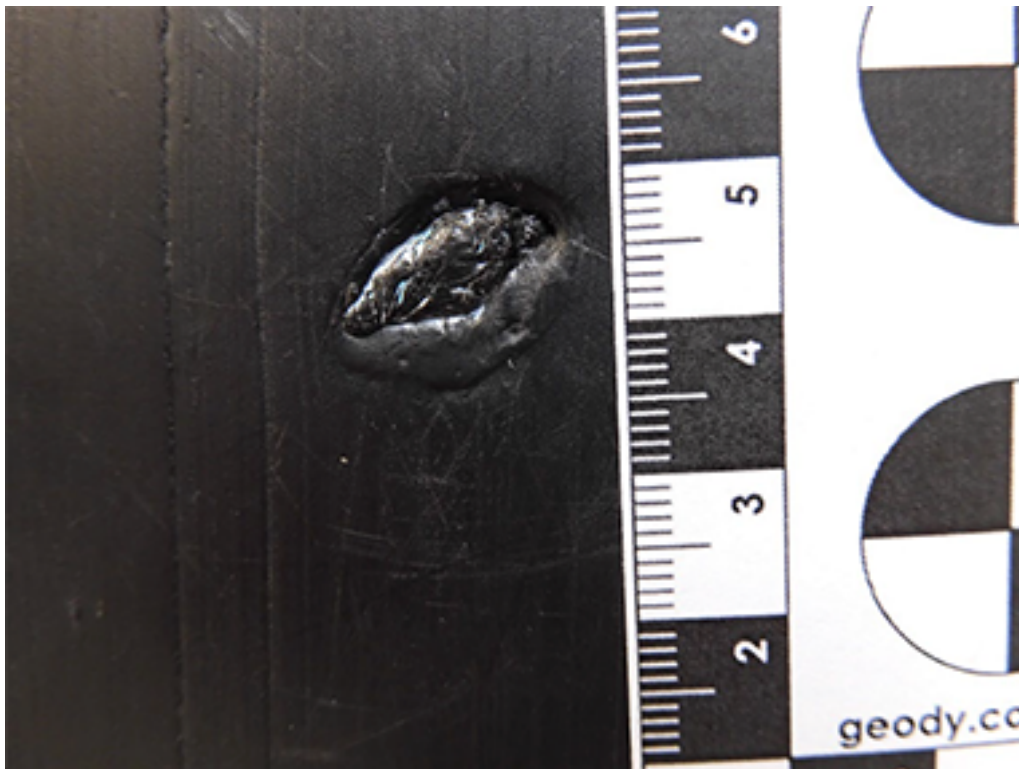
**Figure 4-9** — Surface inclusion — loose extruded resin “pressed” into the pipe surface

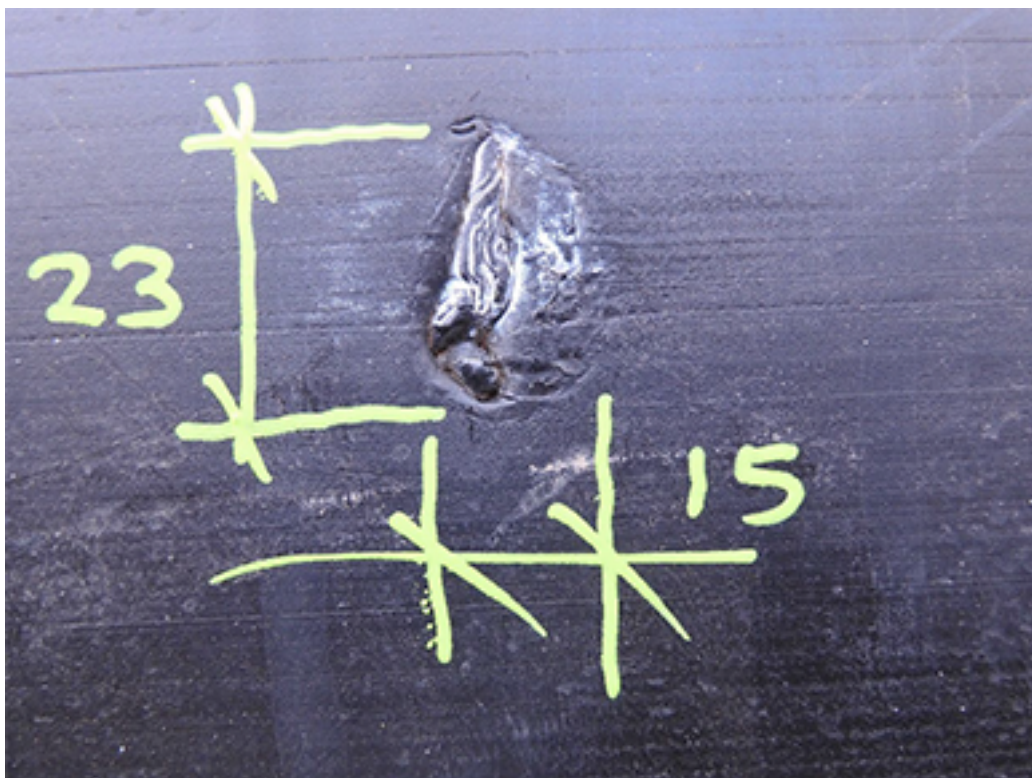
**Figure 4-10** — Surface inclusion

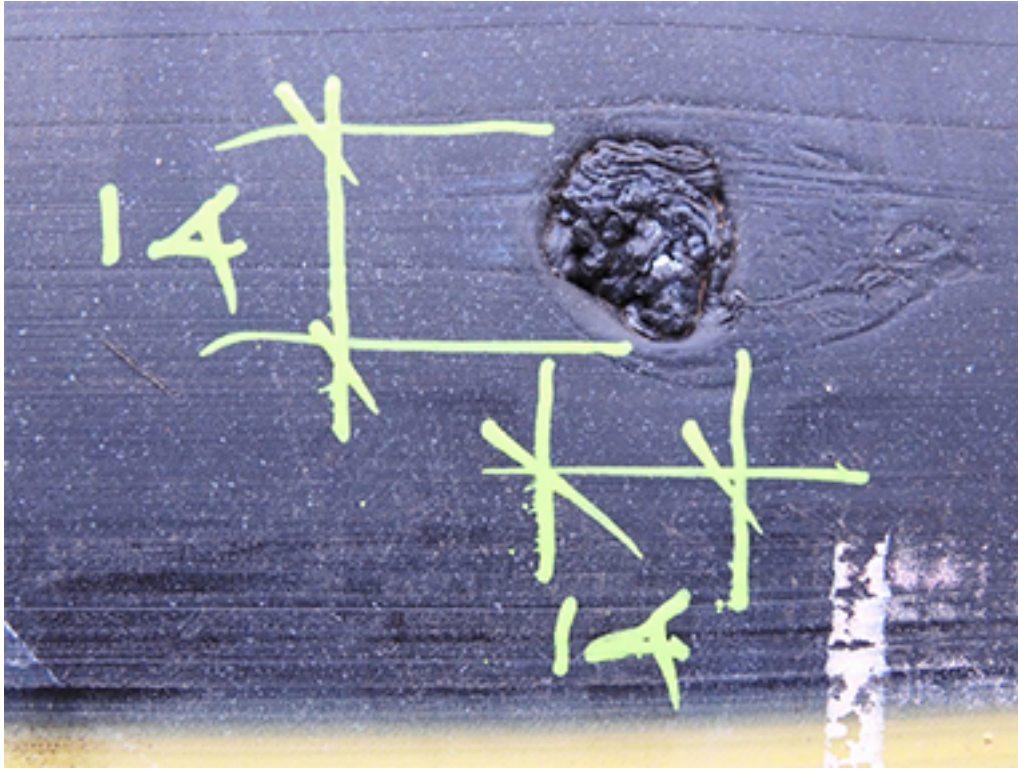
**Figure 4-11** — Surface inclusion. Loose extruded resin being “pressed” into the surface

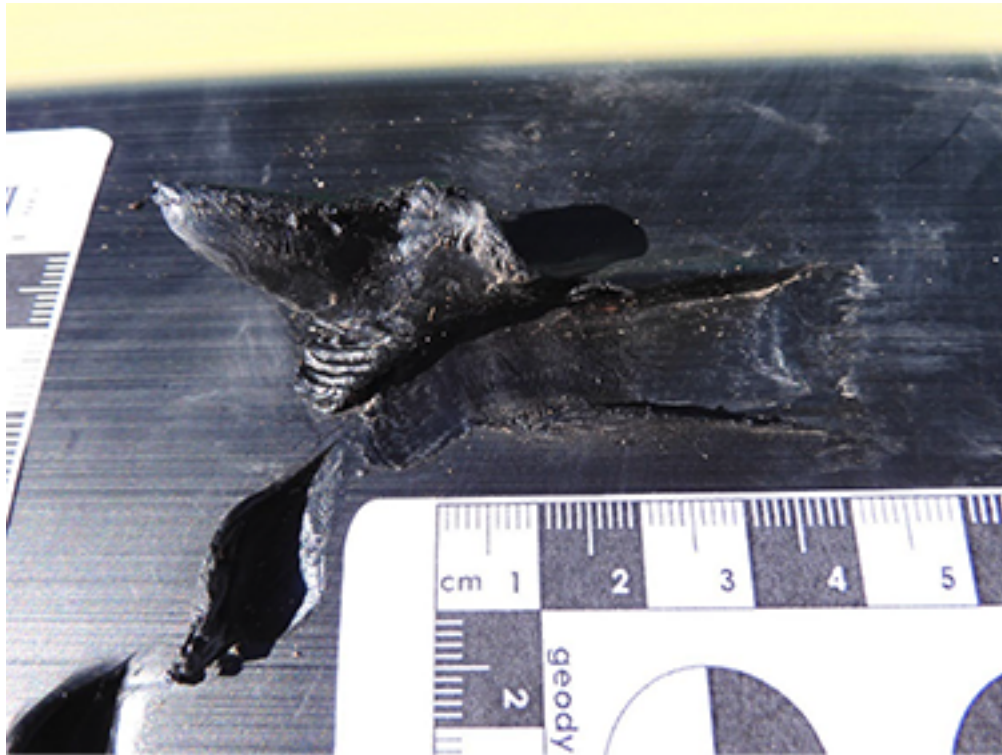
Gouge — this is a linear discontinuity where significant deformation of the material has taken place, (for example see Figure 5.1).

Figure 5-1 — Gouge

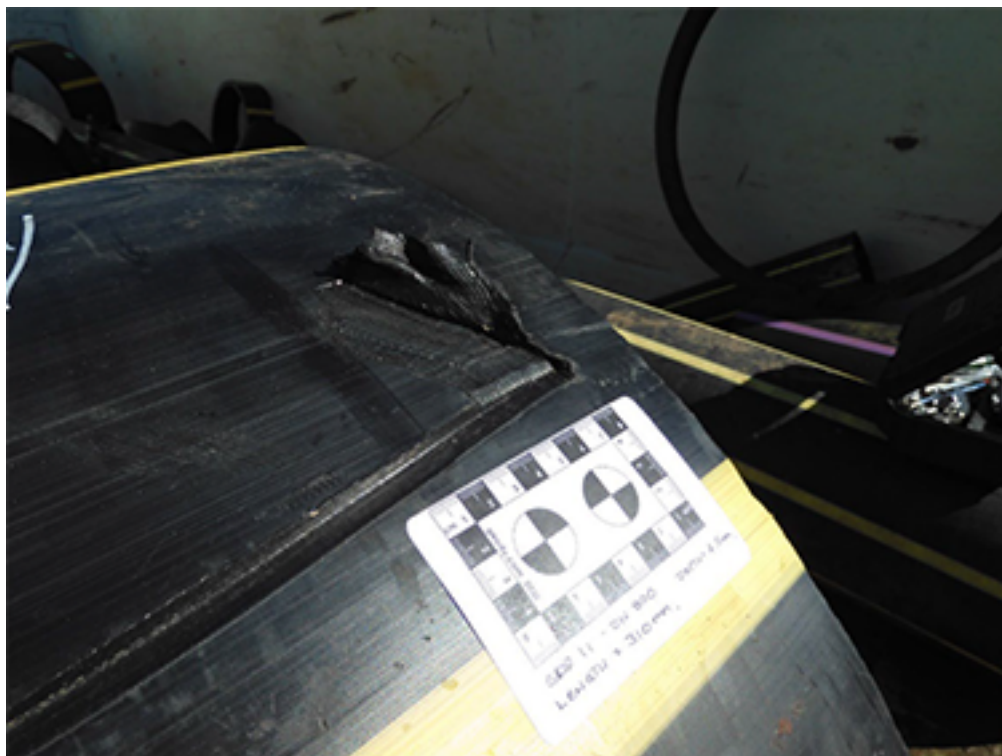
Figure 5-2 — Surface scratch and gouge, this damage is also located at the end of a pipe

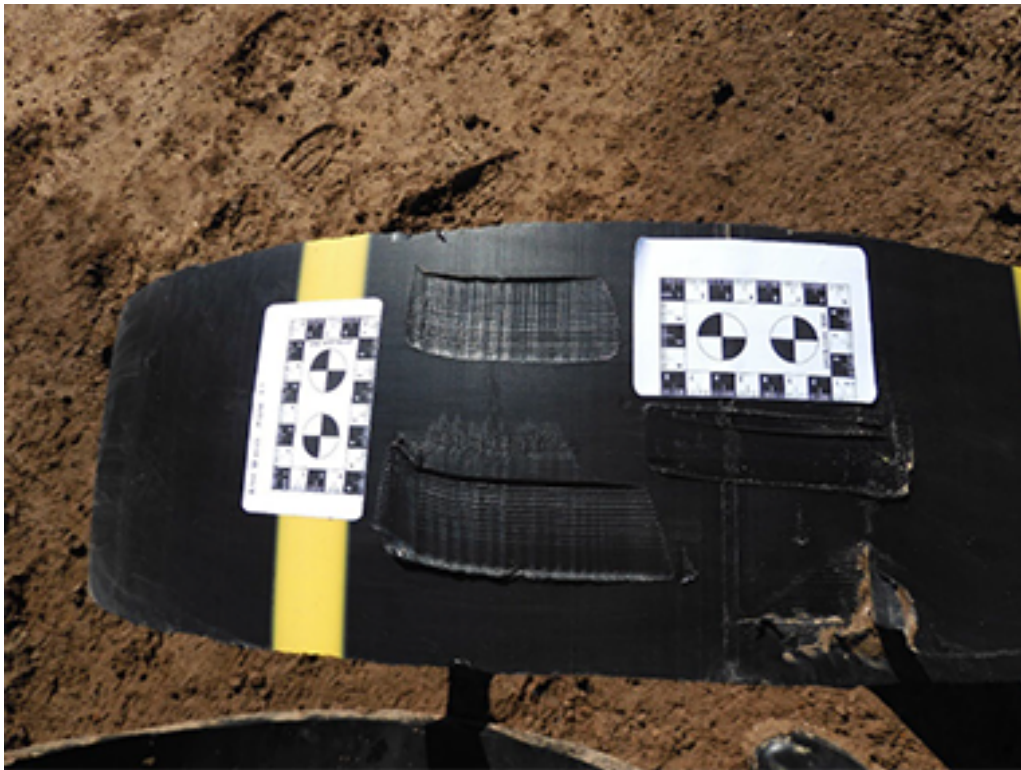
Figure 5-3 — Gouge

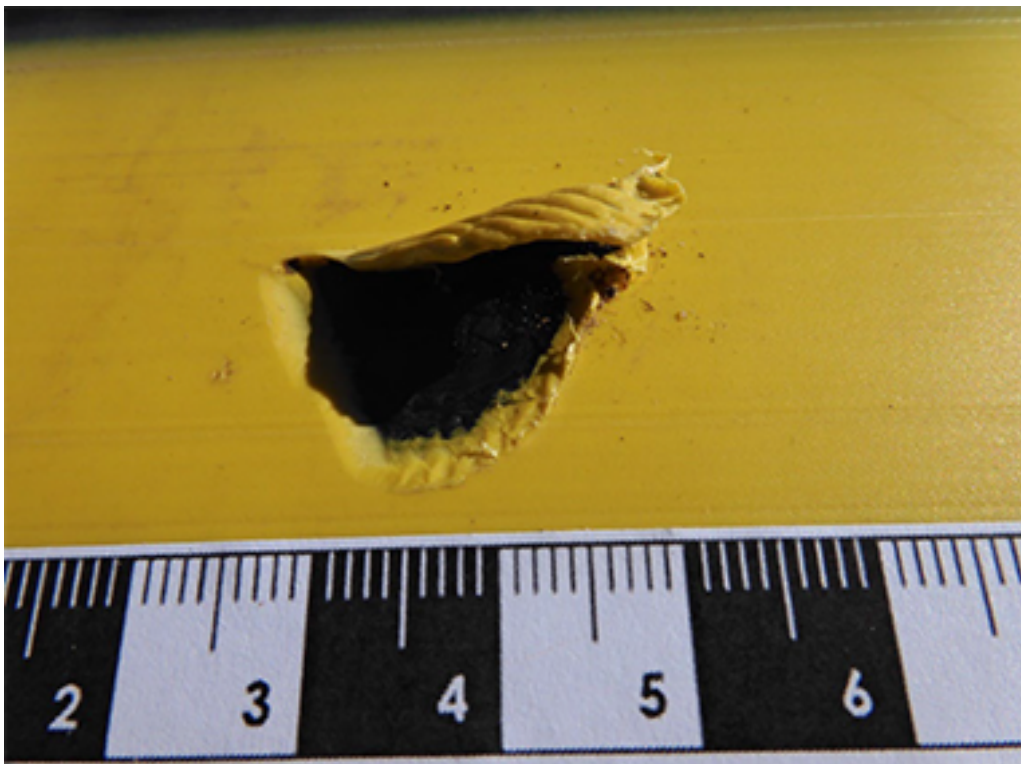
Figure 5-4 — Gouge

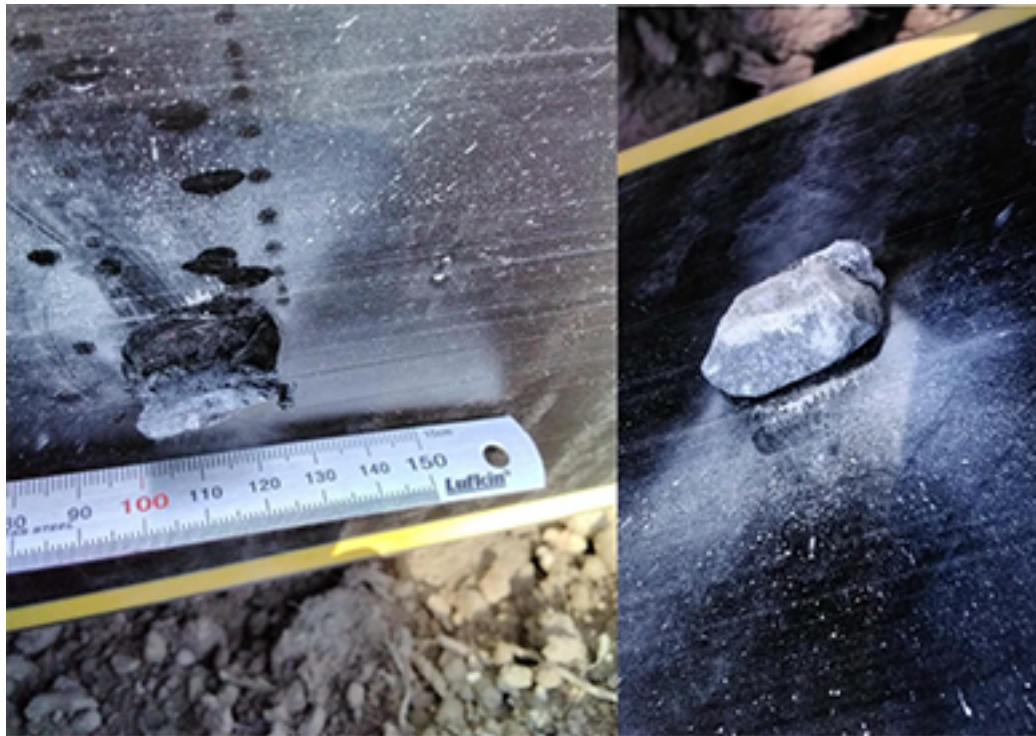
Figure 5-5 — Surface inclusions (stones in this case)

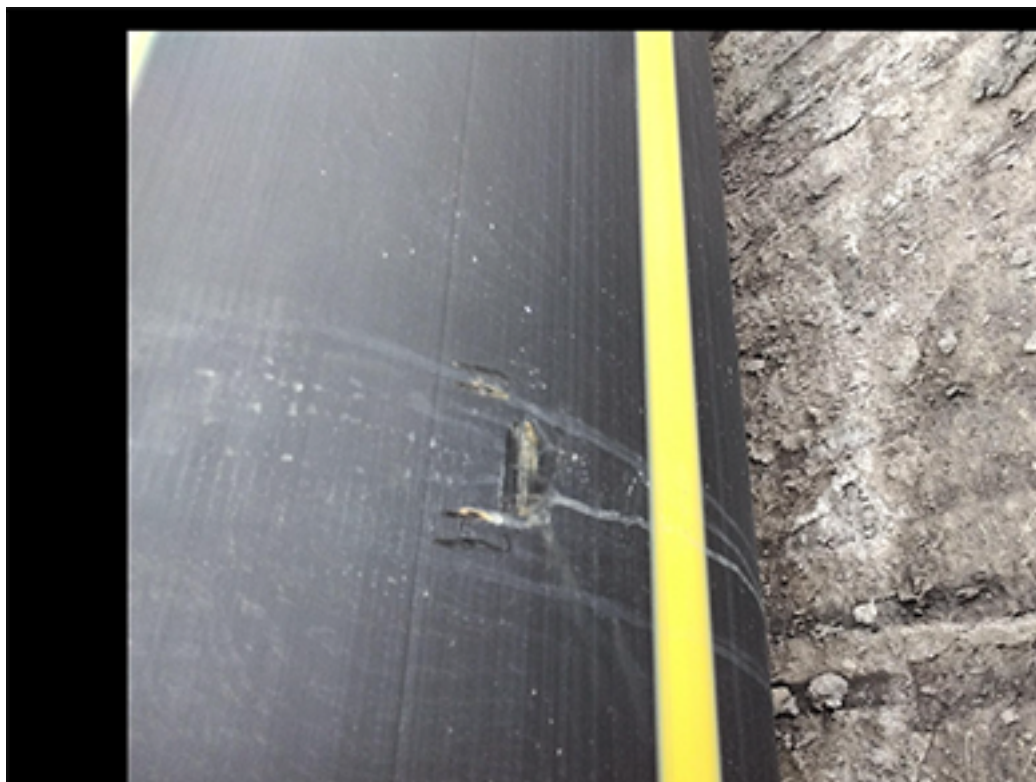
Figure 5-6 — Transport damage from ratchet straps

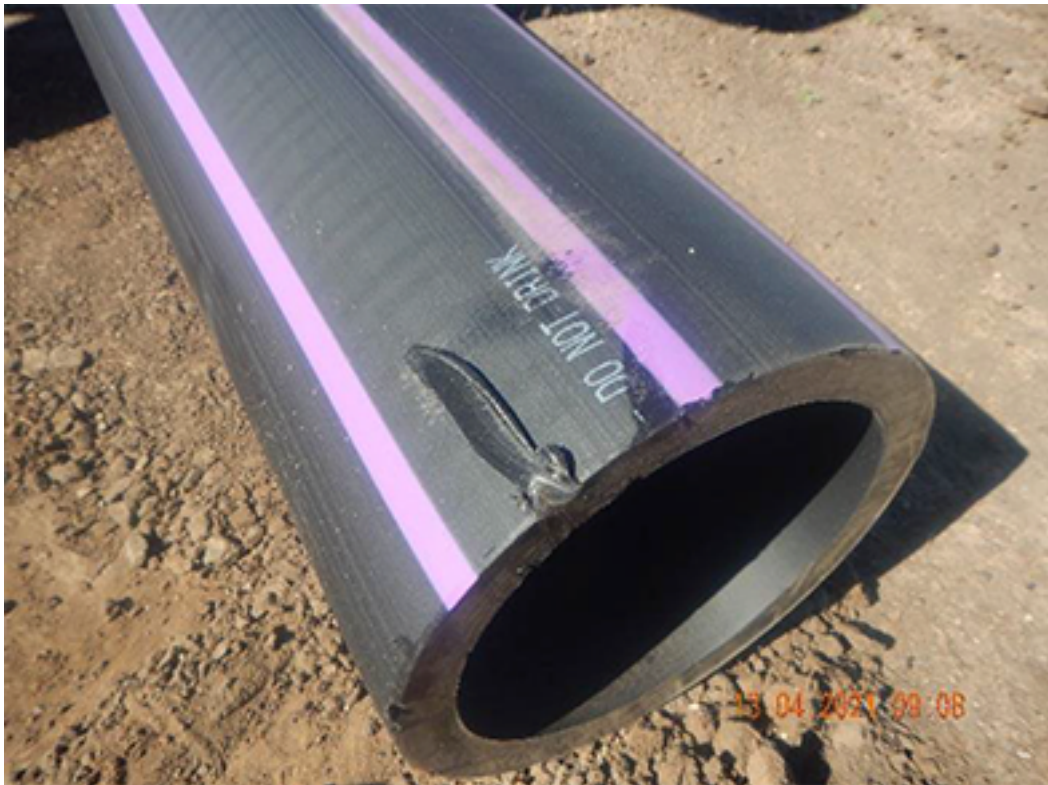
Figure 5-7 — Gouge at pipe end

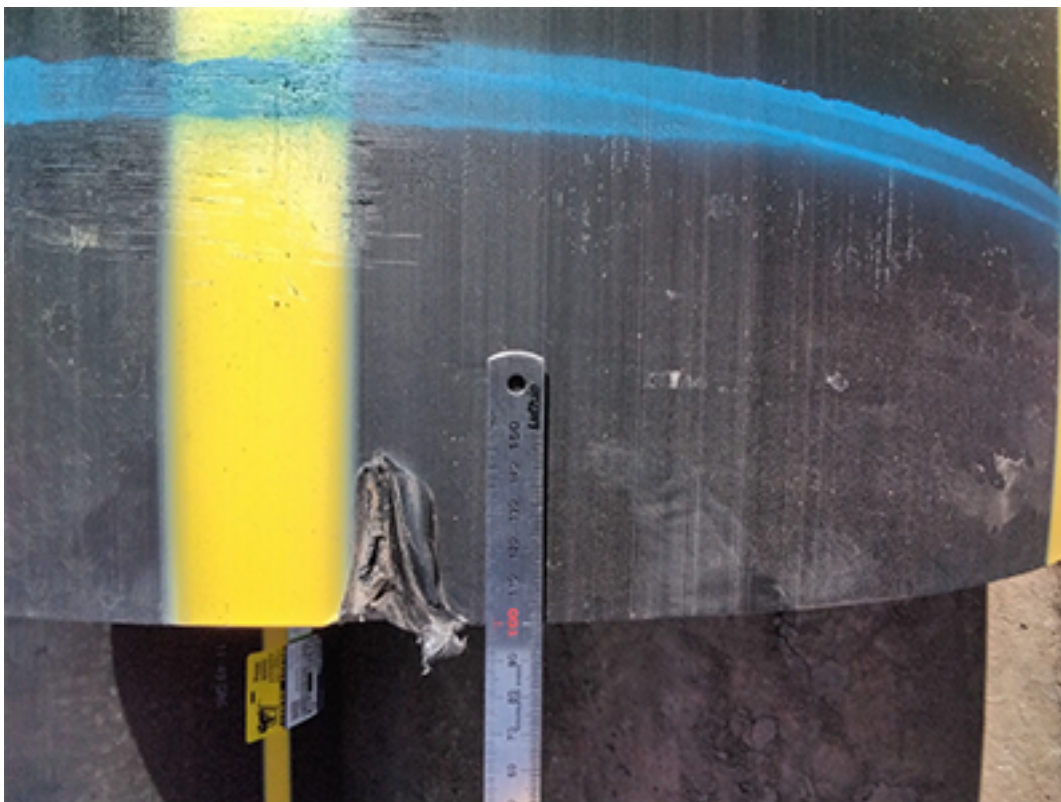
Figure 5-8 — Gouge at pipe end
